Dobashi stone wall

Outline

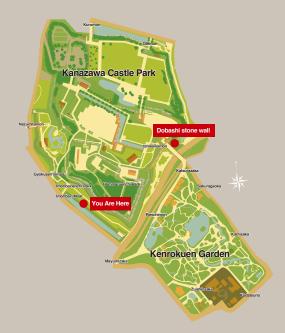
The north facing section of Dobashi stone wall (opposite to Ishikawa-mon gate) was built in the 1630s.

The sections that collapsed in the 2024 Noto Peninsula Earthquake were previously repaired between the end of the Edo period and the Meiji period, using small river stones.

The river stones used measure between 50 and 60cm long. The side or bottom of the stones was partially fractured to create a joint surface with the adjacent stones.
