# Gyokusen'inmaru stone wall

## 【Outline】

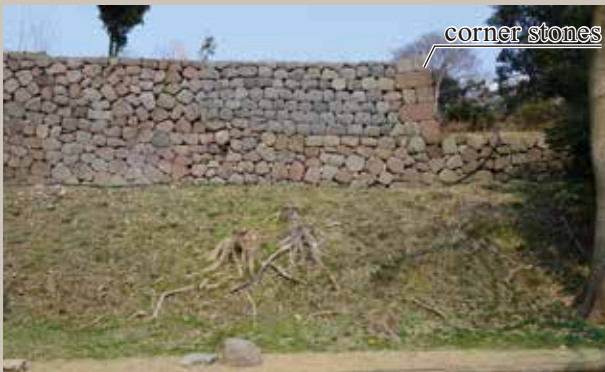
Before earthquake

Most of the stones that collapsed in 2024 were recently added during the renovation in the 1960s. Among these are stones brought from Mt. Tomuro, which were used for the castle walls can be seen at the corners of the walls.
