# Honmaru southern stone wall (stone steps)

## 【Outline】

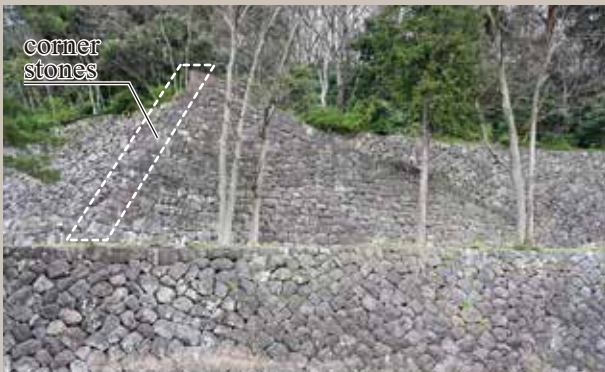
Before earthquake

The stones from the high stone wall were broken up and reused. There is no significant difference in the height or depth of the front of the stones.

The cornerstones were also broken into pieces about half their original size, and their shapes differ from the more boxy originals.

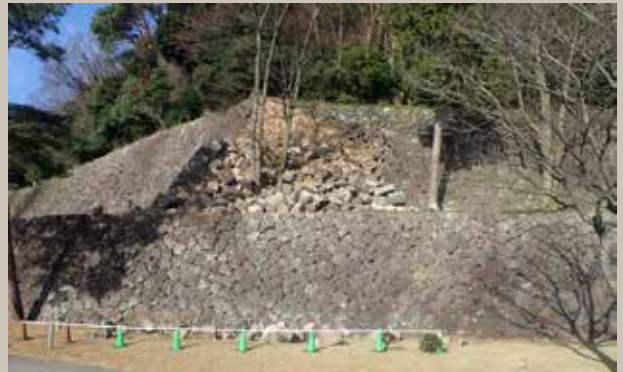
The upper part of the stone wall was removed and replaced with a slope leading up to Honmaru, while the lower part of the stone wall was replaced with new stone steps. This wall collapsed during the 2024 Noto Peninsula Earthquake.

After earthquake
