# Survey and preservation aimed at restoring the stone walls

## Survey and Storage Procedure

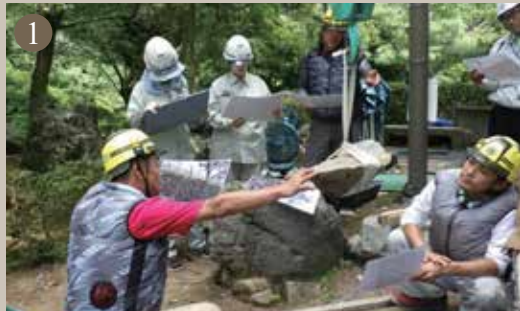
1 We are specifying the original locations of the stones from the collapsed walls.

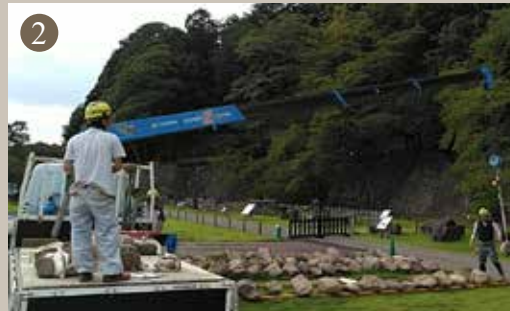
2 We bring stones from the collapsed walls to Imoribori-enchi Park.

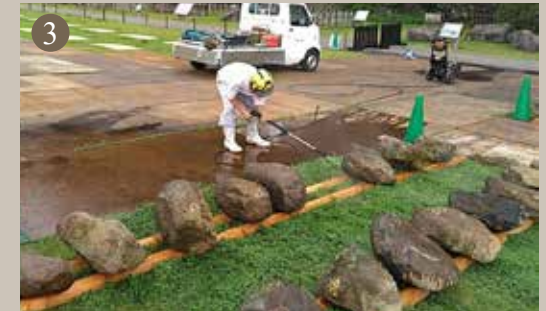
3 We check for cracks and breaks, and wash away any mud stuck to the stones that could cause the walls to collapse or deform.

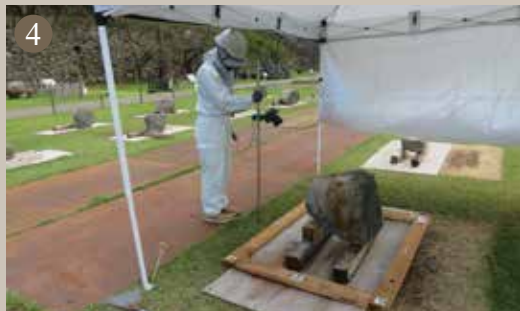
4 We photograph each side of the stones

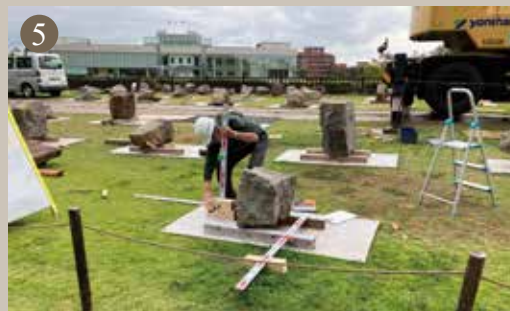
5 We measure the dimensions of the stones

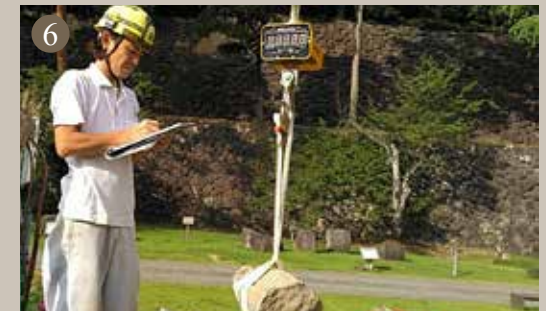
6 We record the weights and conditions of the stones and store them until the reconstruction
